Quality Assurance and Source Inspection

Contract #: 04-0120F4Cty: SF/ALA Rte: 80 PM: 13.2/13.9File #: 69.28**WELDING INSPECTION REPORT****Resident Engineer:**Siegenthaler, Peter**Address:** 333 Burma Road**City:** Oakland, CA 94607**Report No:** WIR-019504**Date Inspected:** 29-Jan-2011**Project Name:** SAS Superstructure**OSM Arrival Time:** 700**Prime Contractor:** American Bridge/Fluor Enterprises, a JV**OSM Departure Time:** 1900**Contractor:** Zhenhua Port Machinery Company, Ltd (ZPMC), Changxing Island **Location:** Shanghai,China**CWI Name:** Cheng Xi/Geng wei**CWI Present:** Yes No**Inspected CWI report:** Yes No N/A**Rod Oven in Use:** Yes No N/A**Electrode to specification:** Yes No N/A**Weld Procedures Followed:** Yes No N/A**Qualified Welders:** Yes No N/A**Verified Joint Fit-up:** Yes No N/A**Approved Drawings:** Yes No N/A**Approved WPS:** Yes No N/A**Delayed / Cancelled:** Yes No N/A**Bridge No:** 34-0006**Component:** OBG**Summary of Items Observed:**

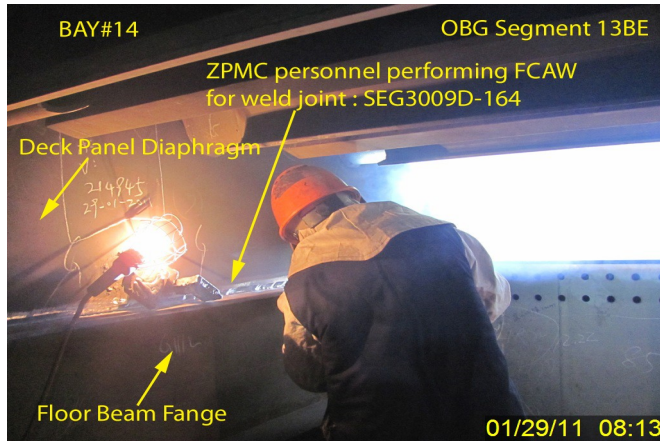
FCAW in the 2G position for the OBG Segment 13BE Deck panel diaphragm to Floor beam flange. The weld joint was designated as: SEG3009D-164. The welder is identified as #214945. ZPMC QC is identified as Mr. Zhong Yong Hong .The welding variables recorded by QC appear to comply with WPS-B-T-2232-ESAB. Please see the attached picture.

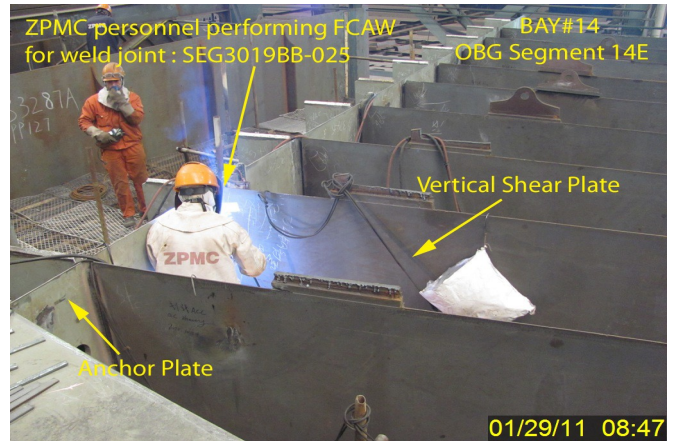
FCAW in the 3G position for the OBG Segment 14E Anchor Plate to Vertical Shear Plate. The weld joint was designated as: SEG3019BB-025. The welder is identified as #067877. ZPMC QC is identified as Mr.Guo shi hui . The welding variables recorded by QC appear to comply with WPS-B-T-2233-ESAB.Please see the attached picture.
